NASA TN D-3321

EFFECTS OF SHUNT CAPACITANCE
ON TRANSIENT EFFECTS CAUSED BY
ELECTRON IRRADIATION OF A POLYETHYLENE
TEREPHTHALATE INSULATED RIBBON WIRE

by William E. Miller and Donald H. Phillips

Langley Research Center

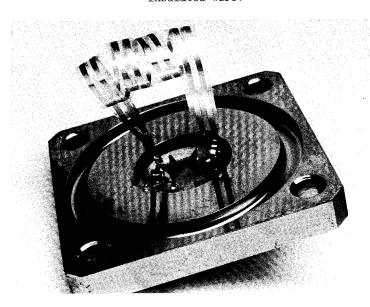
Figure 2.- Ribbon-wire sample ready for mounting.

The test sample as tested is shown mounted on an electrical feedthrough plate in figure 2. The sample was a strip 0.762 centimeter wide of polyethylene terephthalate. Two flat copper conductors were imbedded in the polyethylene terephthalate. The thickness of the sample was 0.127 millimeter (5 mil) and the length was 20.3 centimeters. The copper conductors were 1.5 millimeters wide and 0.0762 millimeter thick and were separated by 1.5 millimeters. The insulation was stripped from the ends of the piece of ribbon wire for a distance of approximately 1.5 centimeters. The ribbon wire was then coiled and the ends were soldered to the electrical feedthroughs on the plate. Figure 3 shows the sample in place in the vacuum target chamber, as viewed from a point behind the target. The rigidity of the ribbon wire was such that no external means of support was necessary.

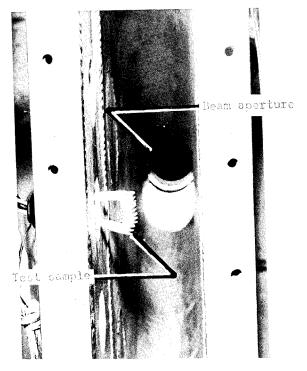
Figure 3.- Sample mounted in target chamber.

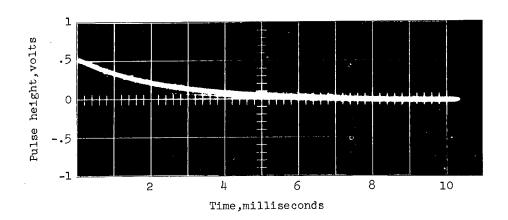
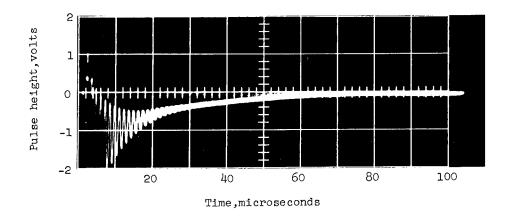
Figure 5.- Two typical pulses obtained from test sample.

The oscilloscope was used in the single sweep mode so that each voltage pulse could be recorded separately. The trigger level of the oscilloscope was set at approximately 0.5 volt. Many pulses with direct-current amplitudes less than 0.5 volt were obtained with this system. In these cases, the oscilloscope was triggered by brief ringing at the leading edge of the signal. (See fig. 5.) The direct-current level of all pulses obtained was used in determining the average pulse heights.

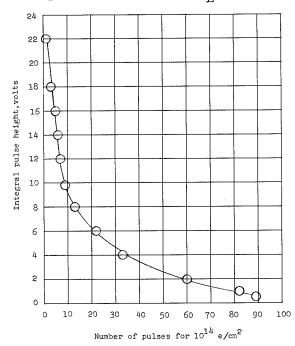
Figure 6.- Number of pulses above a given voltage from the polyethylene terephthalate insulated ribbon wire. Plot is for a 0.0022-microfarad data point.

A typical pulse-height distribution for the sample tested is shown in figure 6. At the higher pulse heights, relatively few pulses were observed. For each test, the average pulse height was found by summing the absolute voltage of each pulse and dividing the result by the total number of pulses observed in that test. The total number of pulses for each test was approximately the same as that shown in figure 6; however, the integral pulse height varied as a function of the total capacitance of the system. Examination of the data showed the voltage pulses to be irregular with respect to time and pulse height.

A curve satisfying equation (2) has been fitted to the data shown in figures 6 and 7. Within the accuracy of measurement this curve fits the data quite well and thus supports the postulate of reference 1.

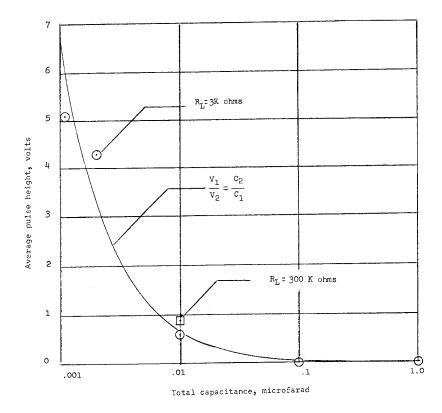
Figure 7.- Average pulse height obtained for a given total capacitance.

Effect of shunt capacitance on average pulse height. The effect of total circuit capacitance on the average observed pulse height is shown in figure 7. The absolute magnitudes of both positive and negative pulses were used to obtain the average pulse height. The average pulse height decreased from 5.1 volts at a total circuit capacitance of 1.1×10^{-9} farads to less than 0.01 volt at a total capacitance of 1.0×10^{-7} farads.

tance of 1.0×10^{-8} farads is also shown in figure 7. Increasing the load resistance by two orders of magnitude from 3 000 ohms to 300 000 ohms produced less than an order of magnitude change in the average pulse height measured.

Since equation (2) is a satisfying fit to the observed pulse heights, equation (1) may be used to obtain an indication of the magnitude of the charge transfer involved in the discharges. Thus, an average charge transfer for the data presented in figure 7 is of the order of 6.6×10^{-9} coulombs and the maximum charge transfer indicated by the data of figure 8 is on the order of 44×10^{-9} coulombs. Calculations indicate that this latter charge would have been adequate to produce an 11 000-volt pulse in the 4-picofarad sample of wire if there had been no external capacitance at all.

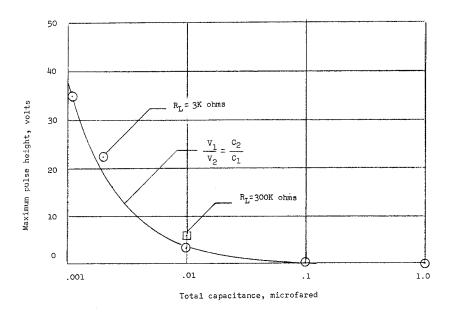
Figure 8.- Maximum pulse height obtained for a given total capacitance.

Effect of shunt capacitance on maximum pulse height. The effect of increasing total capacitance on the maximum pulse height observed is shown in figure 8. The maximum pulse height decreased from 35 volts at a total capacitance of 1.1 × 10⁻⁹ farads to approximately 0.2 volt at a total capacitance of 1.0 × 10⁻⁷ farads.

Effect of load resistance on maximum pulse height .- The effect of increasing the load resistance on the maximum pulse height observed at a total capacitance of 1.0×10^{-8} farads is shown in figure 8. The maximum pulse height observed also increased by less than an order of magnitude with an increase of load resistance by two orders of magnitude (from 3 000 ohms to 300 000 ohms).

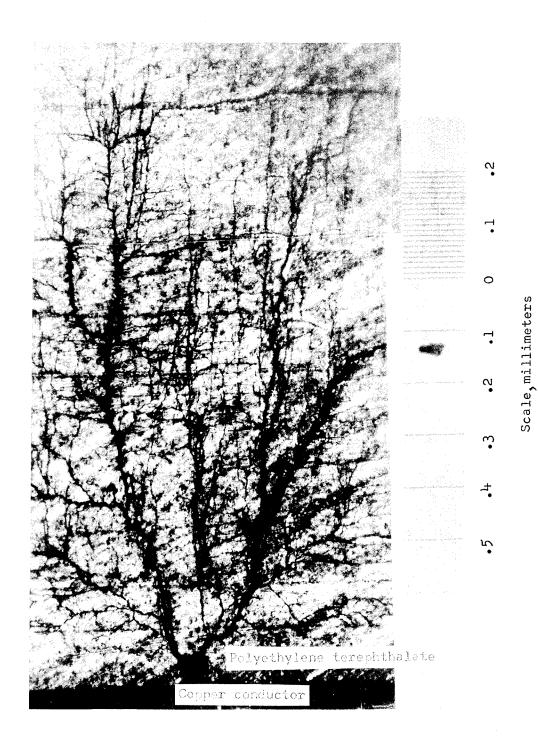
(a) Specimen showing no bulb.

Figure 9.- Discharge pattern in polyethylene terephthalate irradiated with 60 KeV electrons.

After the irradiations it was noted that the portions of the coiled polyethylene terephthalate insulated ribbon wire that had been exposed to the direct electron beam exhibited a slight foggy white discoloration. The polyethylene terephthalate was examined under a microscope and was found to contain a large number of microscopic Lichtenberg figures. Figure 9 shows three of these Lichtenberg figures in the polyethylene terephthalate terminating at the copper conductor of the ribbon wire. The thickest part of the discharge trunk is on the order of 15 microns. In the thickest part of the trunk there is usually a region (on the order of 50 to 100 microns in diameter) that is different in size and shape from the rest of the

discharge trunk. This bulbous region may have been vaporized by the discharge. This effect is shown in figure 9. Large Lichtenberg figures have been noted in polymethyl methacrylate (ref. 3), borosilicate glass (ref. 4), and radiation shielding glass (ref. 5) following electron irradiation.

It is evident from the extent of the Lichtenberg figures produced in the dielectric (fig. 9) that the discharge from the dielectric is from a relatively small region of the material. Thus, an extension of the above calculations to a sample of dimensions on the order of those of the Lichtenberg figures would result in voltages substantially in excess of the aforementioned values.

It is of interest to make a rough calculation of the power density along the trunk of the discharges shown in figure 9. The energy transferred is of the order of 11×10^3 volts times 44×10^{-9} coulombs, or 5×10^{-4} watt-seconds. The trunk diameter of the discharge as evidenced by the damage indicated in figure 9 is on the order of 15 microns; that is, the local energy density along the trunk during the discharge is on the order of 270 watt-seconds/centimeter². Now, the discharge is accomplished during the rise time of the signal. This rise time is so short that it cannot be resolved on an oscilloscope with a rise time of 0.01 microsecond. If 0.01 microsecond is accepted as the discharge time, the local power density along the track is found to be on the order of 3×10^{10} watts/centimeter². Power densities of this order of magnitude should be capable of producing the damage indicated in figure 9, judging from evidence obtained with laser beams given in reference 6.

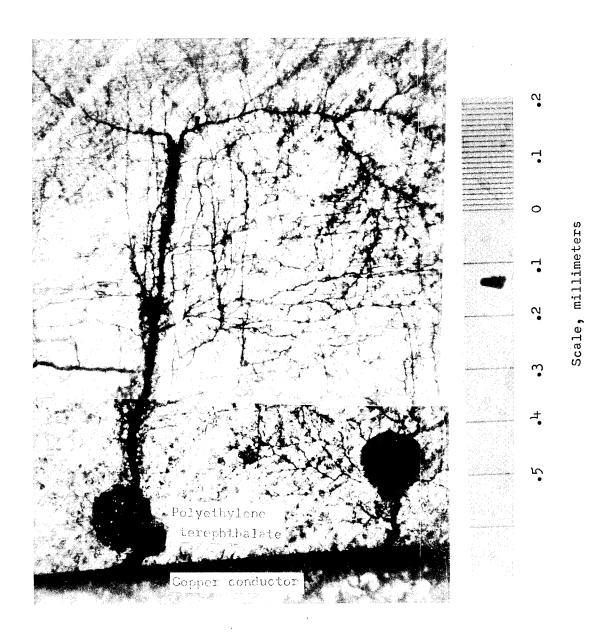
(b) Specimen showing bulb.

Figure 9.- Concluded.
